**CANADIAN FORCES
FLIGHT SAFETY INVESTIGATION REPORT (FSIR)**

FINAL REPORT

FILE NUMBER: 1010-CF188933 (DFS 2-3-3)
DATE OF REPORT: 05 April 2006

AIRCRAFT TYPE: CF188 Hornet
DATE/TIME: 132006Z January 2005
LOCATION: Tinker Air Force Base, Oklahoma City, Oklahoma, USA
CATEGORY: "D" Category Incident

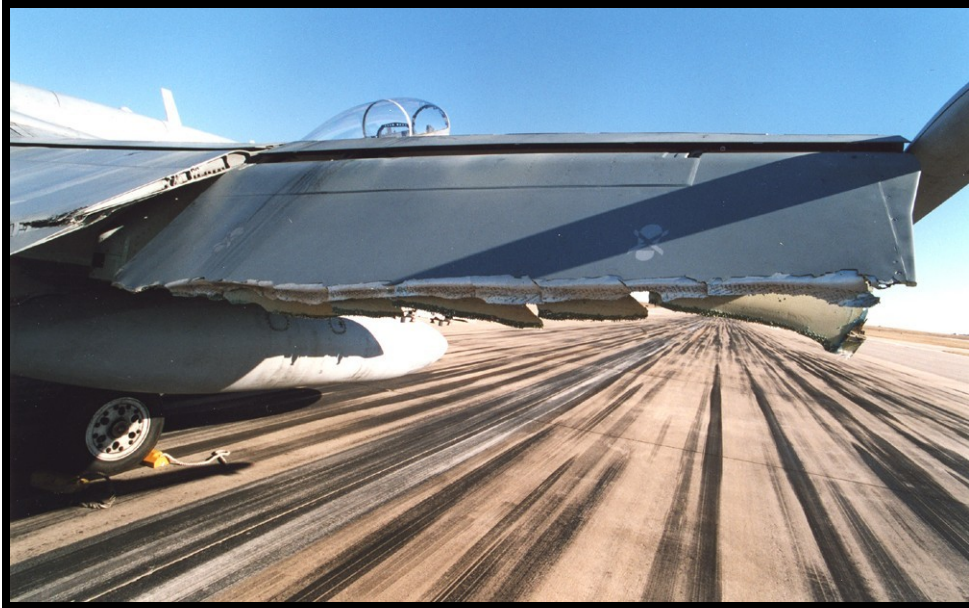
The aircraft sustained "D" category damage. The trailing edge of the right aileron (Photo 1 and 2), the right trailing edge flap (Photo 3), and the leading edge of the right horizontal stabilator (Photo 4) were damaged after being struck by a 50-foot section of E-5 arrestor cable. Additionally, the aircraft arrestor hook bearing sleeve assembly was damaged (Photo 5) as it was forced into a position 70° right of centre. There was no other indication of visible damage to the aircraft. There were no fluid leaks or spills.

3.1.16 The failed cable and associated components caused damage to the arrestor hook assembly, right aileron, right flap and right horizontal stabilizer of the aircraft. (2.3.3 and 1.3)

Photo 1: Right Aileron.

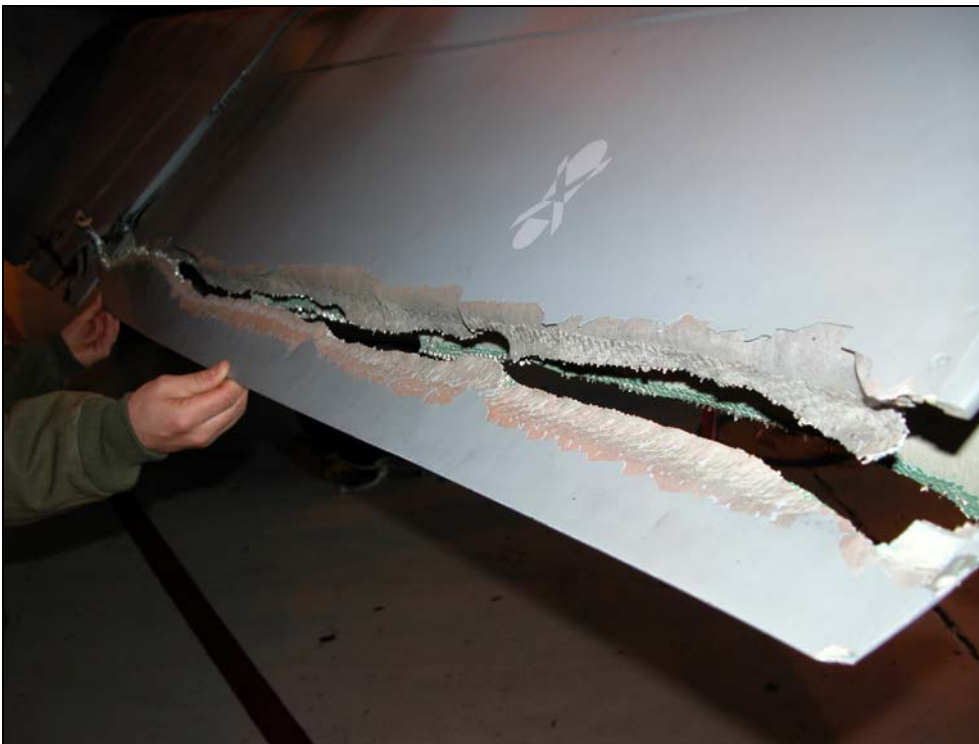
Photo 2: Right Aileron

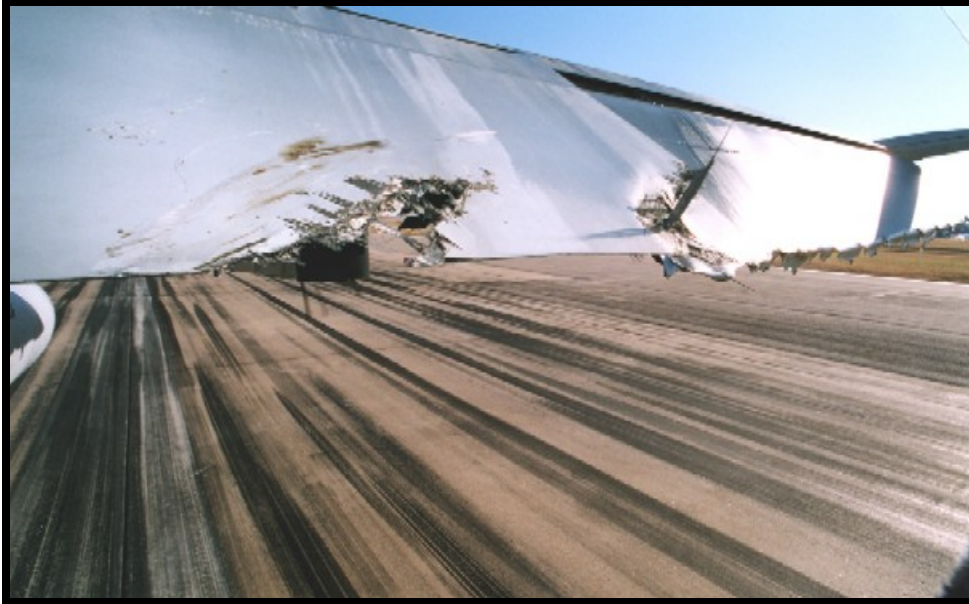
Photo 3: Right Flap.

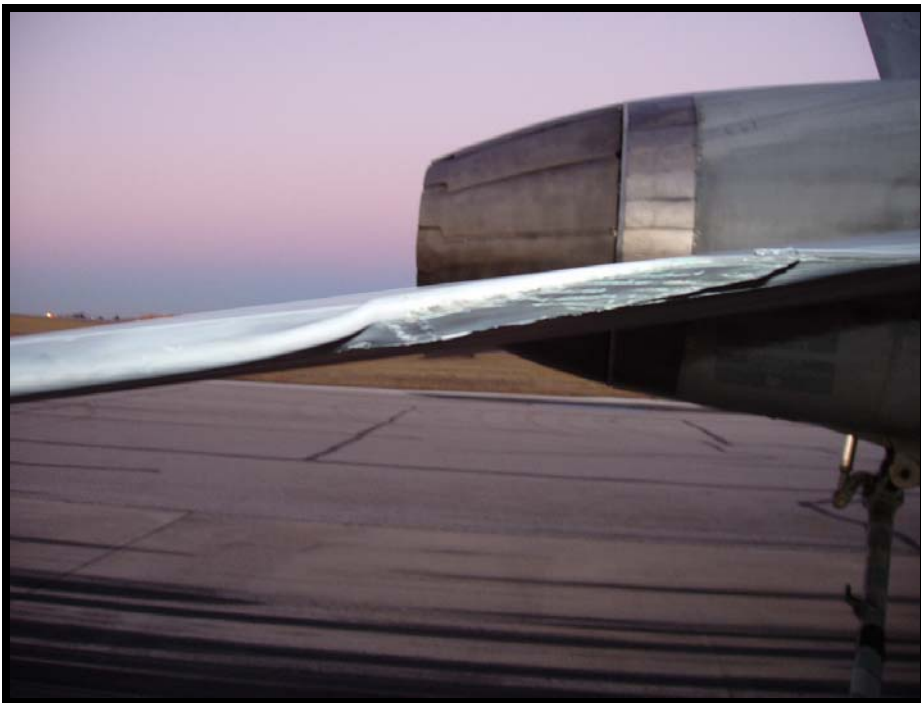
Photo 4: Right Horizontal Stabilator.

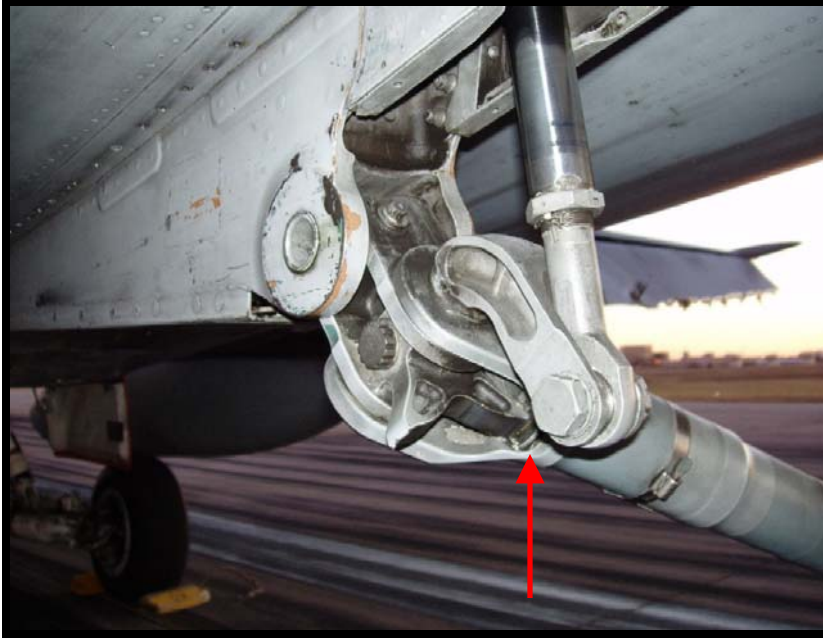
The airborne engagement of the E-5 arrestor cable, which was configured for runway 30 overrun, resulted in the near instantaneous failure of the arresting hook and cable, and significant damage to various aircraft components (as listed in paragraph 1.3). On landing, the aircraft experienced significant and sudden directional control problems. The PIC was able to stabilize the aircraft before engaging emergency brakes. The aircraft came to a stop approximately 7500’ from the threshold of runway 12. The BAK-12 arrestor cable was not engaged as intended due to damage to the aircraft arrestor tail-hook from the E-5 cable.

Photo 5: Stop Arrestor Hook Assembly Showing Cracked Gear Bearing Sleeve Assembly

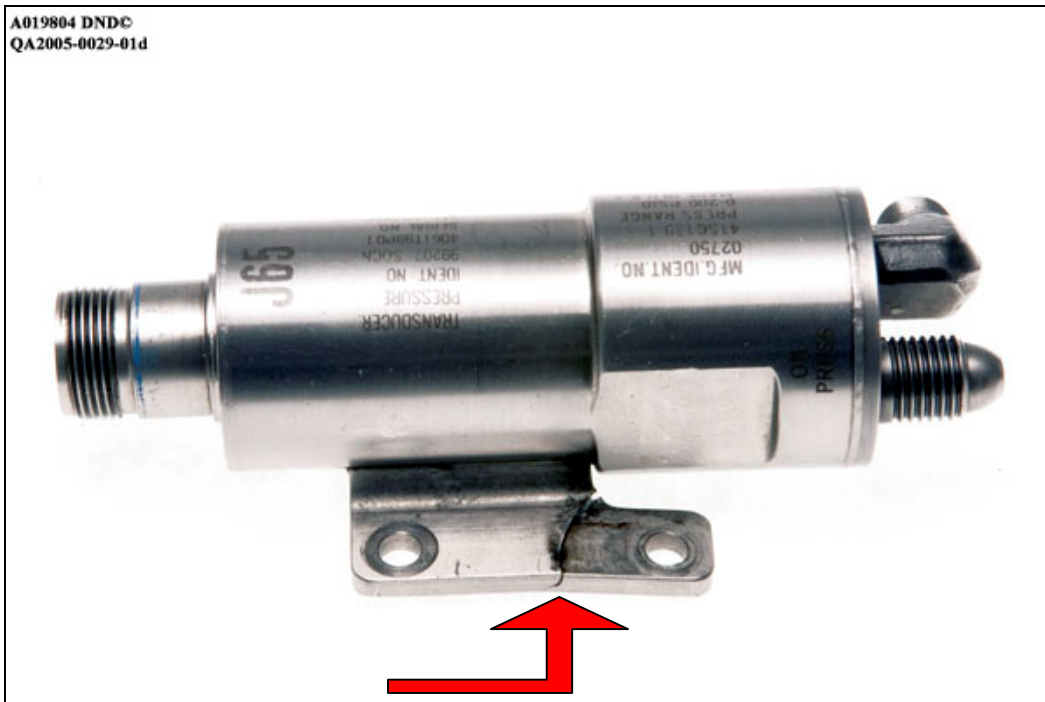
Testing of the right engine oil pressure transmitter (photo 6) indicated it to be serviceable, although excessive wear on the connector pins was noted. Debris from the worn pins and some oil contamination was also found in both the

transmitter and the transmitter connector. Testing of the wire harness assembly resulted in the duplication of the low oil pressure indication.

Photo 6: Oil Pressure Transmitter

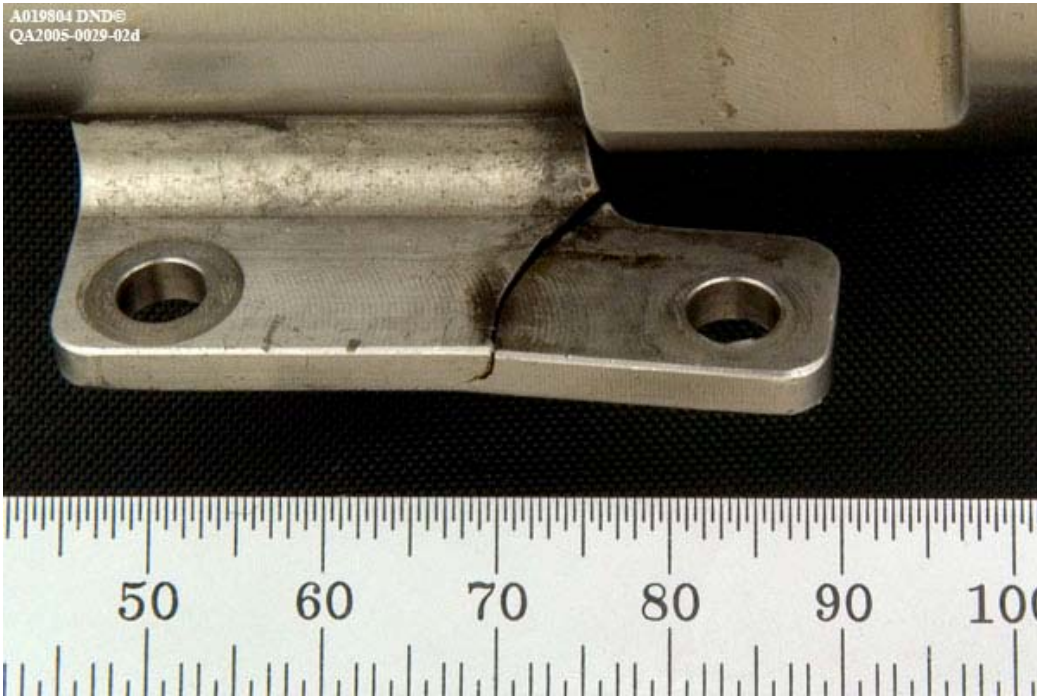
3.1.2 The engine oil pressure transmitter mount had suffered a fatigue fracture (high cycle, low load condition) that caused premature wear of a connector pin, which in turn caused erratic oil pressure indication. (2.2.1)

3.3.1 The design of the oil pressure transmitter (mount, wire, and connector) is prone to vibration-induced failures. (2.2.1)

Photo 7: Close-up of cracked oil pressure transmitter mount

4.2.1 A visual inspection of the oil pressure transmitter mounting bracket should be conducted during any inspection that requires the oil pressure transmitter to be inspected. (3.1.3)

4.2.2 The Canadian CF-18 fleet should adapt an improved engine oil pressure transmitter bracket to replace the CF bracket as soon as possible. (4.1.2)

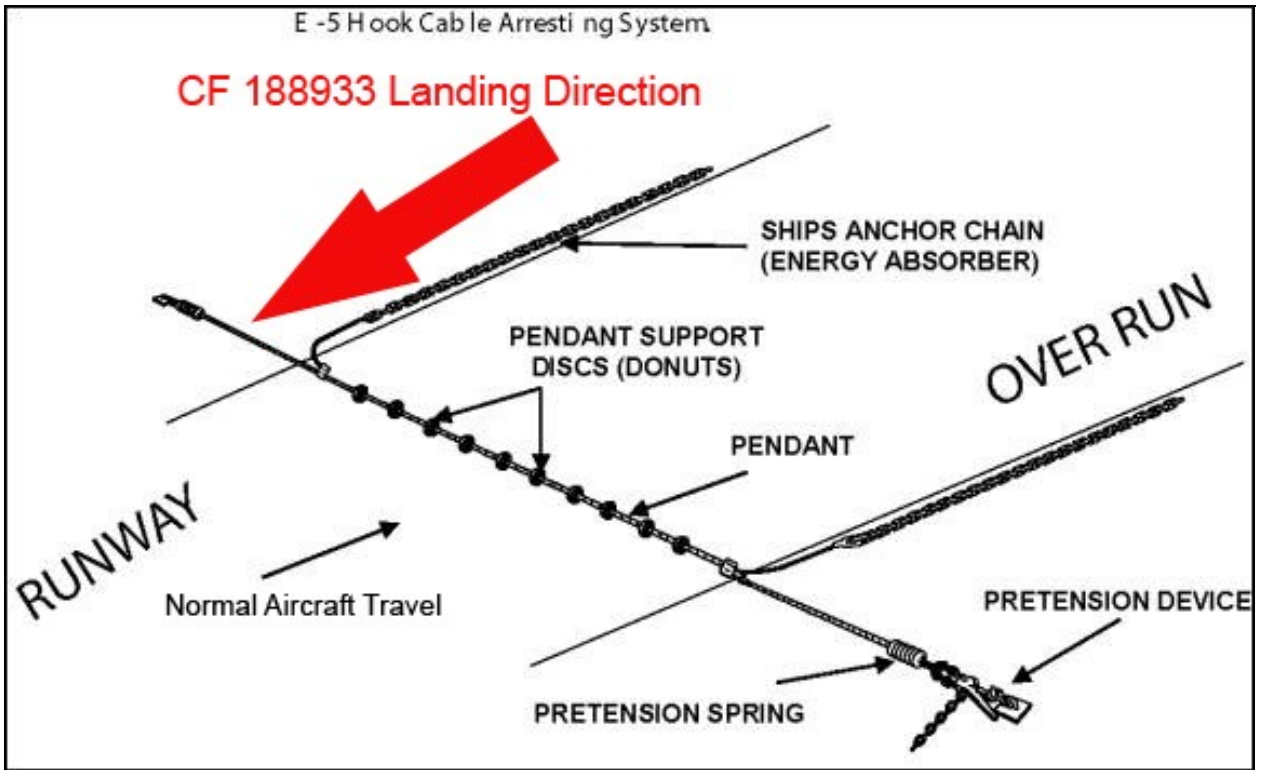
Figure 2: E-5 Arrestor System

In addition to the approach-end cable, there is an E-5 arrestor cable located 70 feet prior to the approach end of runway 12. The E5 (figure 2) is a unidirectional emergency arresting system. This system uses several lengths of ships' anchor chain as the energy absorber. The system is designed so that as an aborting aircraft engages the arrestor gear it causes the anchor chain to fold back on itself. The result is that the amount of drag progressively increases as the aircraft decelerates. In the case of this accident the arrestor gear was engaged by the airborne CF-18 traveling in the opposite direction. The result was that the entire drag of the anchor chain was immediately absorbed by the CF-18. A caution in the CF-18 AOIs state that “An engagement in the wrong direction with chain gear will severely damage the aircraft”.

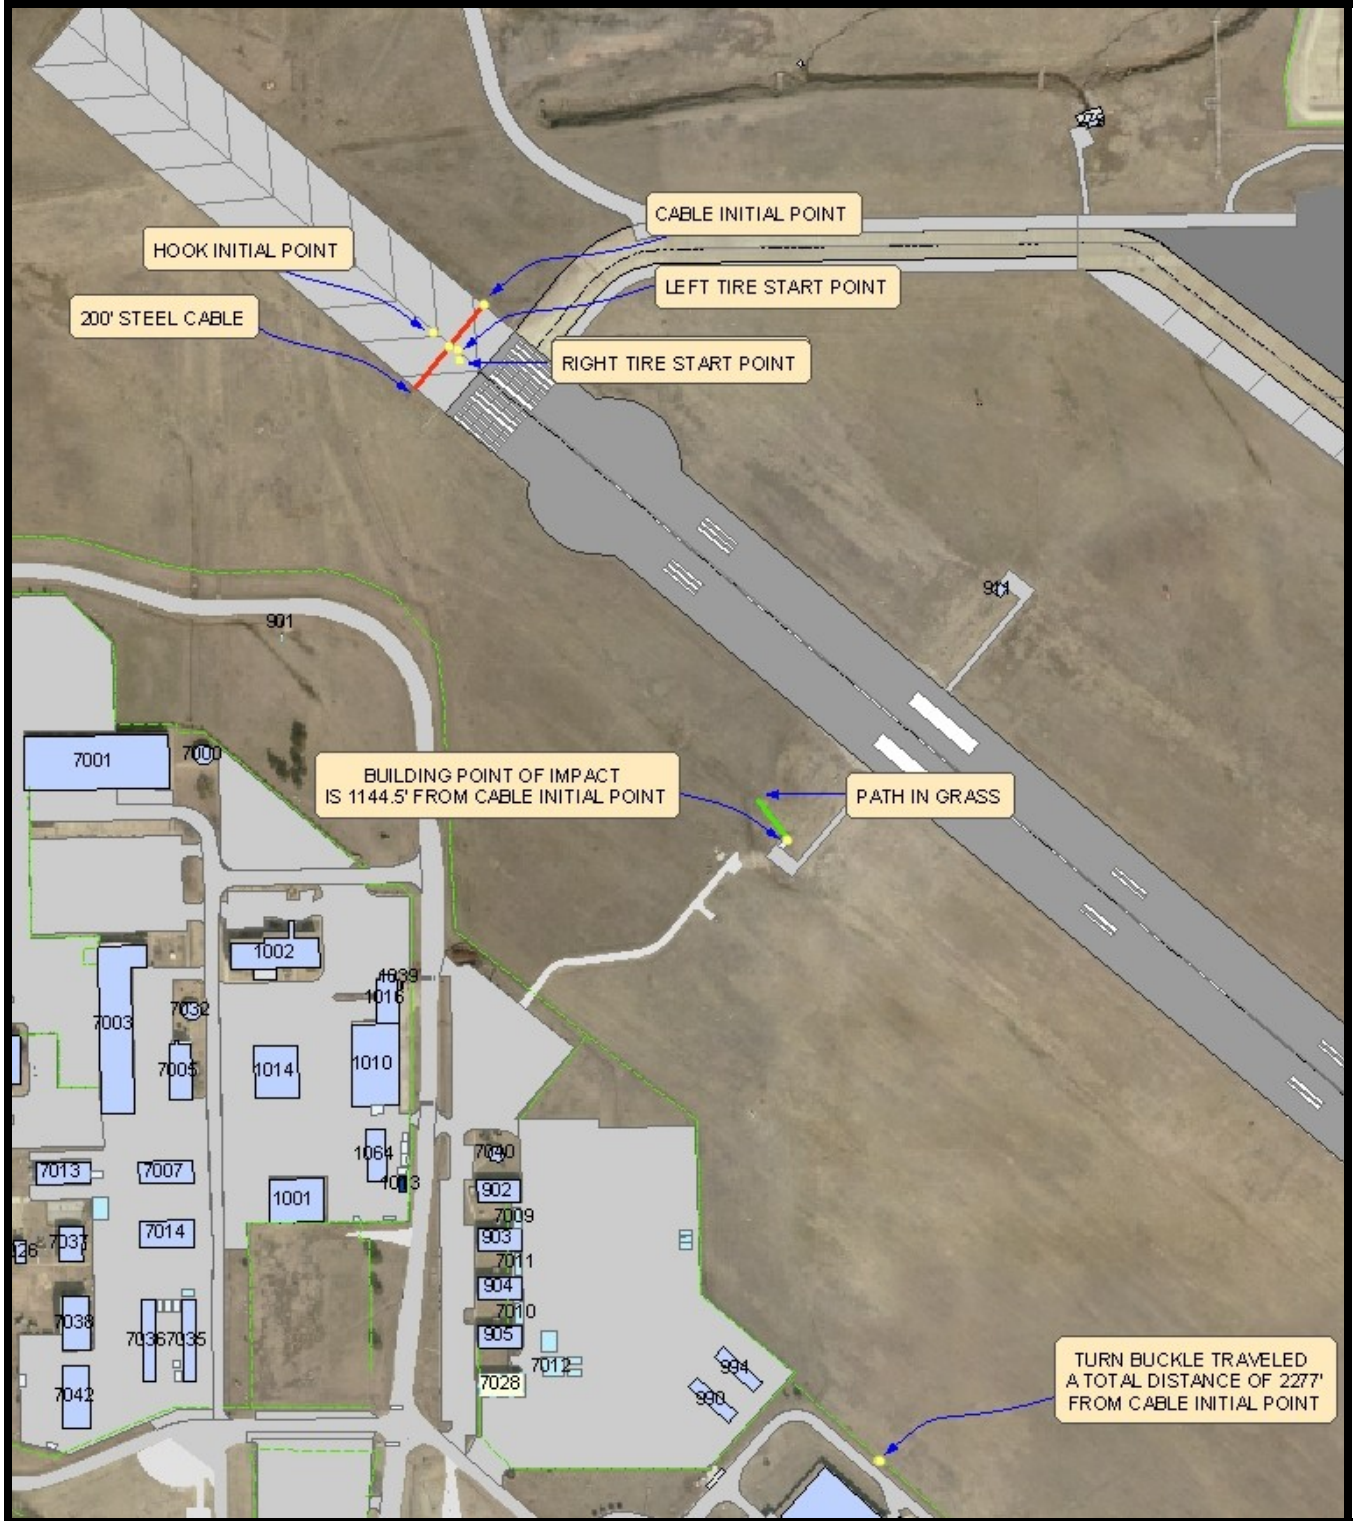
Figure 3: Tinker AFB Runway Diagram

area. Runway 12/30 has a total of four arrestor cables: landing runway 12 is equipped with an approach-end BAK-12 bi-directional arrestor cable located on the runway 1,000 feet past the threshold and a departure-end E-5 unidirectional arrestor cable 60 feet beyond the threshold in the overshoot area; landing runway 30 is similarly equipped with an approach-end BAK-12 bi-directional arrestor cable located on the runway 3208 feet past the threshold and a departure-end E-5 unidirectional arrestor cable 70 feet beyond the threshold also in the overshoot area (figure 3).
